Dendrochronology reveals the construction history of an early 19th century farm settlement, southwestern Virginia, USA

The McDonald Farm (also called the Anderson-Doosing Farm) in Catawba Valley, Virginia dates to 1789 and is registered with the National Register of Historic Places maintained by the National Park Service. According to written accounts, oral histories, and architectural analyses, the construction of four structures (a collapsed cabin, a standing cabin, a barn, and a smokehouse) at the farm likely occurred in the early to mid-19th century. To verify and refine the construction dates of the four structures, we absolutely dated the tree rings in logs used in their construction by comparing their ring patterns with a composite reference tree-ring chronology created from four regional locations. We used established graphical and statistical techniques used in dendrochronology to ensure that all tree rings were dated absolutely with 99.99% certainty. We found cutting dates for the collapsed cabin ranged from 1809 to 1810, making the likely builder Samuel Myers and not Joseph Anderson, who is currently given credit for its construction. The logs in the barn had cutting da

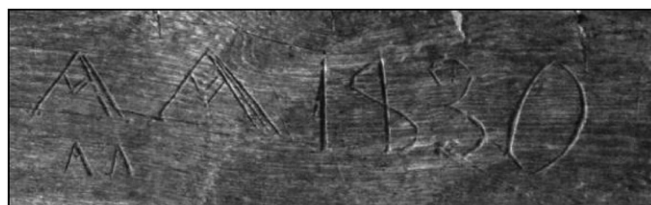
Fig. 1. Carving in one log of the cantilever barn, stating (likely) "A A 1830."

The farm complex today consists of three intact log structures (Fig. S1): a standing cabin, a double-pen cantilever barn, and a smokehouse (but called a "meat house" in the nomination report). Pezzoni (2009) stated that the cabin dates to the "mid-19th Century," the smokehouse to the "early to mid-19th Century," and the barn to "ca. 1830." The current landowners found a tax deed that stated the barn on the property was built in 1814, thus bringing into question the "ca. 1830" date. The 1830 construction date likely came from a carving in one log of the barn that states "A A 1830"

(Fig. 1) (we can infer that the last "A" stands for Anderson, but presume the first "A" may represent the name of a relative). Finally, a collapsed cabin lies across the road from the farm complex, where only the chimney remains standing surrounded by rotting oak log beams.

The nomination, however, was very accurate for the construction date for the barn (“ca. 1830”), a date that likely came from the graffiti found on one of the logs (Fig. 1). We found cutting dates for the barn between 1829 and 1832 (more likely cut in 1830 and 1831), which confirmed the barn was perhaps functional around 1830 (i.e., one pen of the two required for the double cantilever barn had been completed) while construction continued until the barn was complete by the winter of 1831/1832. According to the NRHP nomination, tax records indicated that Joseph Anderson, who owned the property from 1814 to 1837, had buildings on the property, and thus was given credit for building all four structures (Pezzoni, 2009). However, the barn is the only structure that dates to this interval. It seems likely that Anderson lived in the original, now-collapsed cabin built by Samuel Myers and later he and his family built the barn in 1830–1831. In addition, our finding disproved the date on the tax deed the current landowner found that suggested the barn was built in 1814 and instead confirmed the date listed in the nomination report. We cannot, however, discount that a previously-built barn may have once existed at the farm complex to which the tax deed record could be referring.
